邓羽松, 蔡崇法. 红壤丘陵区崩岗侵蚀调查与监测防治技术进展[J]. 土壤学报, 2025, 62 (2): 322–333.

红壤丘陵区崩岗侵蚀调查与监测防治技术进展*

Progress of Survey, Monitoring, and Control Technology of Benggang Erosion in Red Soil Hilly Area

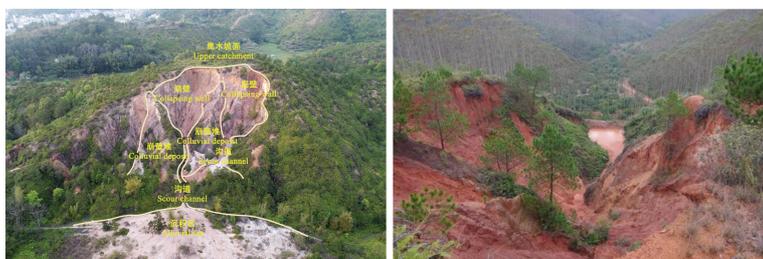
图 1 红壤丘陵区典型崩岗地貌

注：左图拍摄于广东梅州市，右图拍摄于广西梧州市（图片来源：邓羽松 摄）。Note: The left photo was taken in Meizhou City, Guangdong, and the right picture was taken in Wuzhou City, Guangxi Province (Photo source: Deng Yusong) .

Fig. 1 Typical landform of Benggang in the red soil hilly area

南方红壤丘陵区气候高温多雨、农业活动频繁、土壤侵蚀类型复杂，是我国水土流失严重的区域之一^[1]。崩岗是红壤区一种特殊的土壤侵蚀地貌，是指在水力和重力共同作用下，山坡土体受破坏而崩塌和冲刷的侵蚀现象^[2-3]（图 1），可由一定流域面积的沟谷侵蚀发育至高级阶段形成^[4]。完整的崩岗系统组成包括上方的集水区、后缘的崩壁、中部的崩积堆、下部的沟道和沉积区五个基本单元^[5-7]，但针对崩岗发生区域的自然地理要素和人为干扰不同，其组成部分或残存的地貌有所差异。崩岗侵蚀多发生于农业生产区，影响耕地面积高达 38.04 万 hm^2 ，导致区域粮食产量显著减少，土壤退化严重，农田恢复和整理的费用高达 5.5 亿元。崩岗侵蚀模数高达 $3\sim 5 \text{万 t}\cdot\text{km}^{-2}\cdot\text{a}^{-1}$ ，远超过南方 $500 \text{t}\cdot\text{km}^{-2}\cdot\text{a}^{-1}$ 的容许土壤流失量，严重阻碍生态文明建设和社会经济可持续发展，被形象地称为“生态环境溃疡”，引起
